MOSQUITO RUN DAM

NDI No. PA01012

PHASE I INSPECTION REPORT
NATIONAL DAM INSPECTION PROGRAM
PAC N31-81-C-0011

Mosquito Run Dam, Lycoming County, Pennsylvania
NDI No. PA 01012, PennDER 41-2
Mosquito Creek
Inspected 1 April 1981

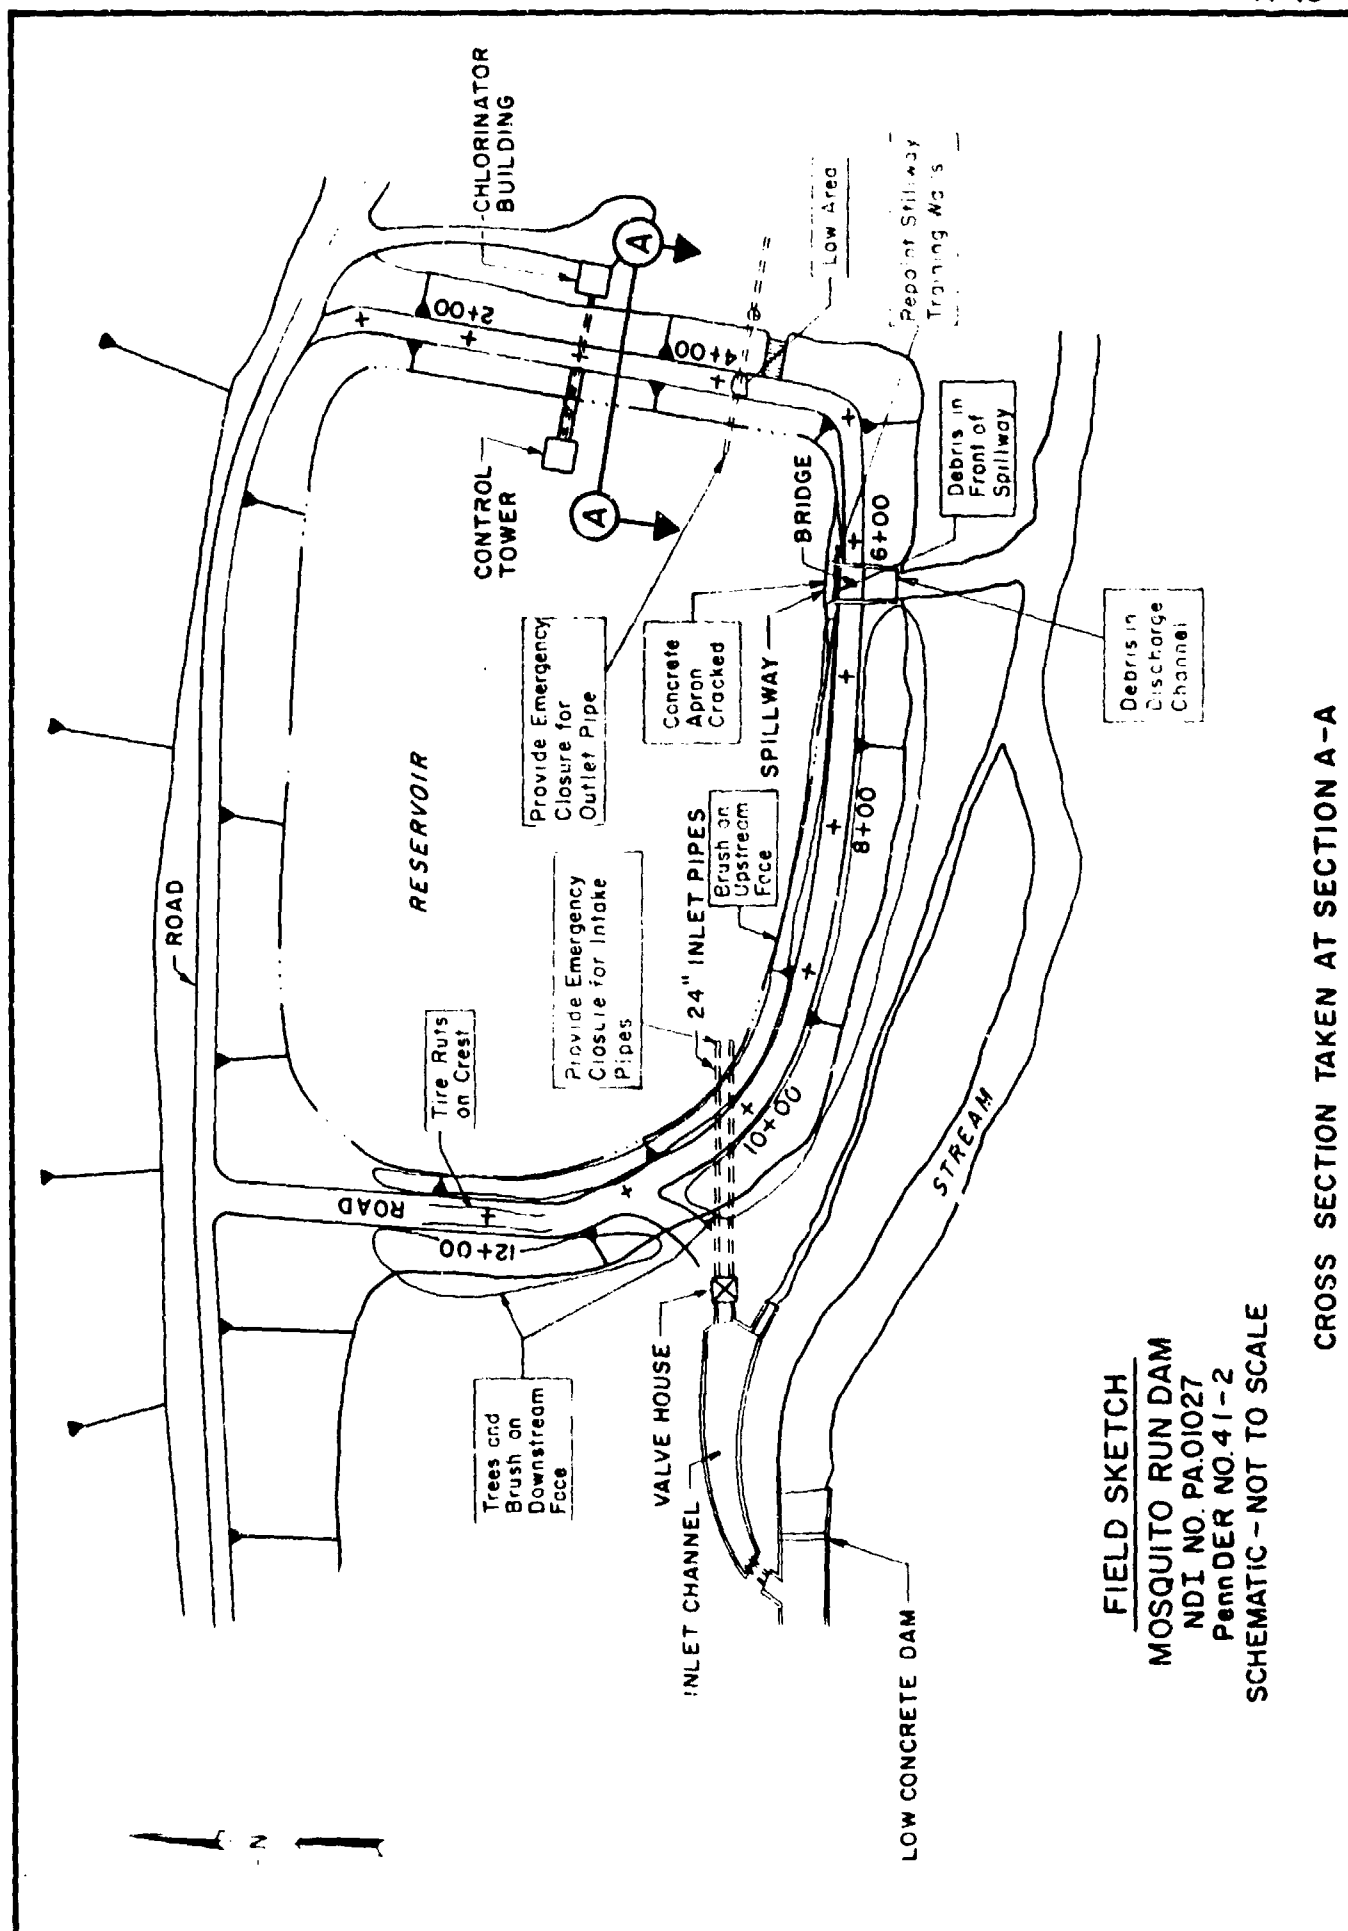
VISUAL EXAMINATION OF	OBSERVATIONS	REMARKS OR RECOMMENDATIONS
VERTICAL AND HORIZONTAL ALIGNMENT OF THE CREST	Horizontal and vertical alignment are good except for the low area noted on the Field Sketch (A-13) and top of dam profile (A-14). Minor vehicle tracks were present on the crest of the dam.	The upstream end of the embankment was constructed higher than the downstream end. Fill and seed the low area and the tire tracks on the crest of the dam.
